IDENTIFYING PROBLEMS WITH POST TENSION CONCRETE

BALCONY SLABS

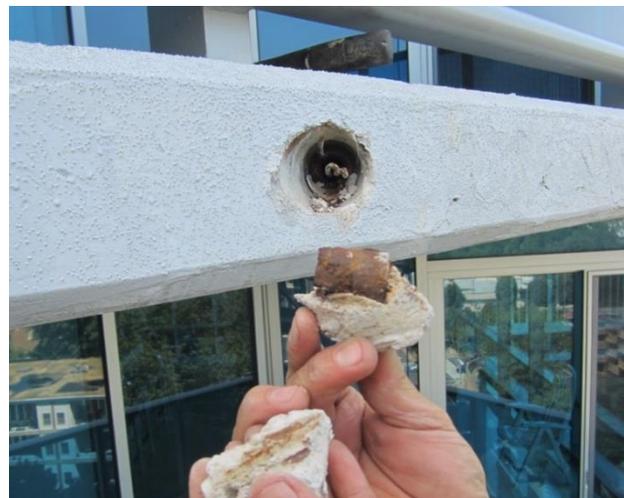
Photo 2 – removed grout revealing corroded wedges and anchor due to water intrusion at the grout pocket

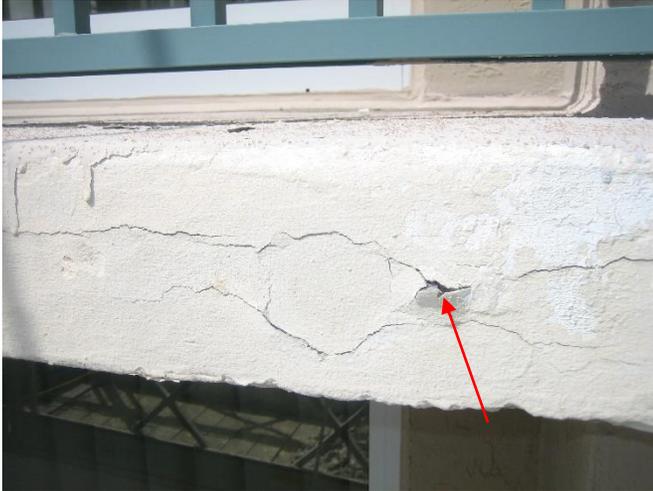
Photo 3 – Close view of a balcony slab edge with cracks and deteriorated coating. This condition permits water and oxygen to reach the embedded steel PT anchors and mild reinforcing steel.

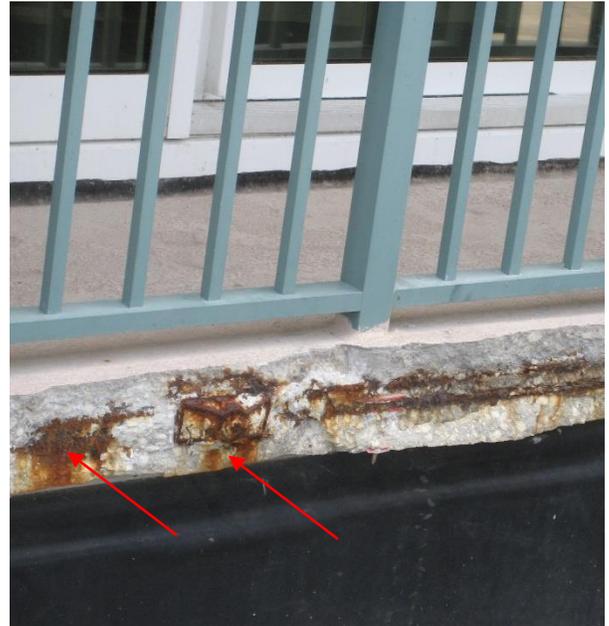
Photo 4 – Balcony slab edge after delaminated concrete was removed revealing corroded PT anchors and mild reinforcing steel.

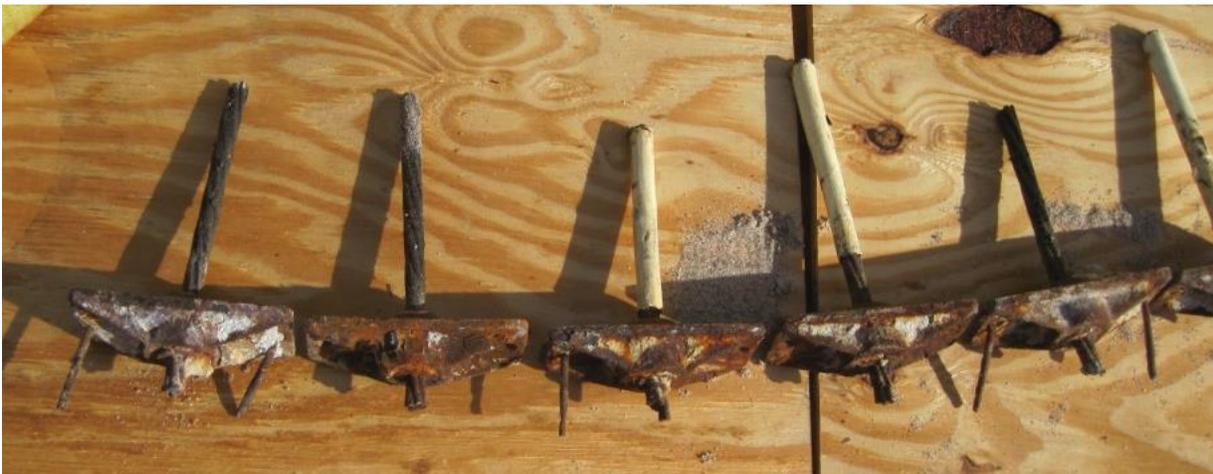
Photo 5 – Corroded PT anchors and tendons after removal from a balcony slab

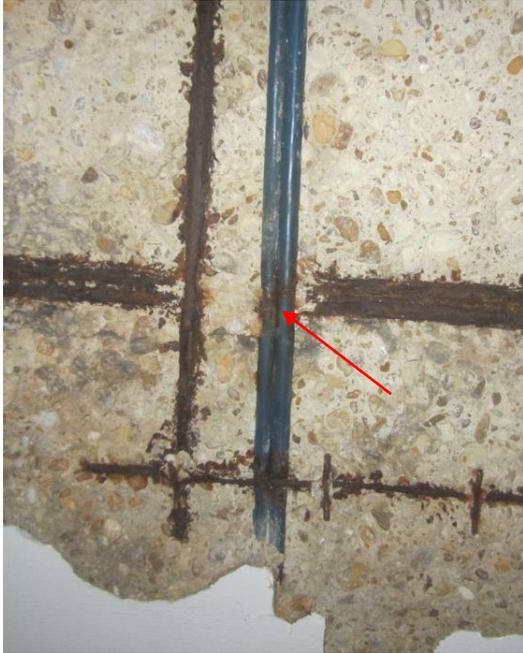
Photo 6 – View of garage slab bottom surface after delaminated concrete had dislodged and fallen from the soffit revealing corroded PT tendons and mild reinforcing steel.

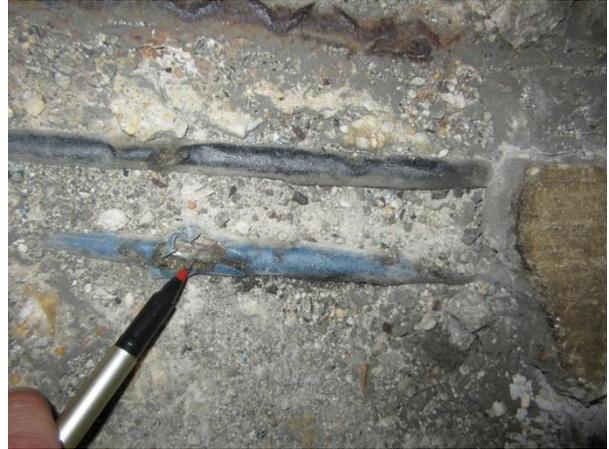
Photo 7 – A damaged PT tendon on a garage mat slab top surface. The previously delaminated concrete has exposed this cable to damage from vehicular traffic, water and deicing salts.

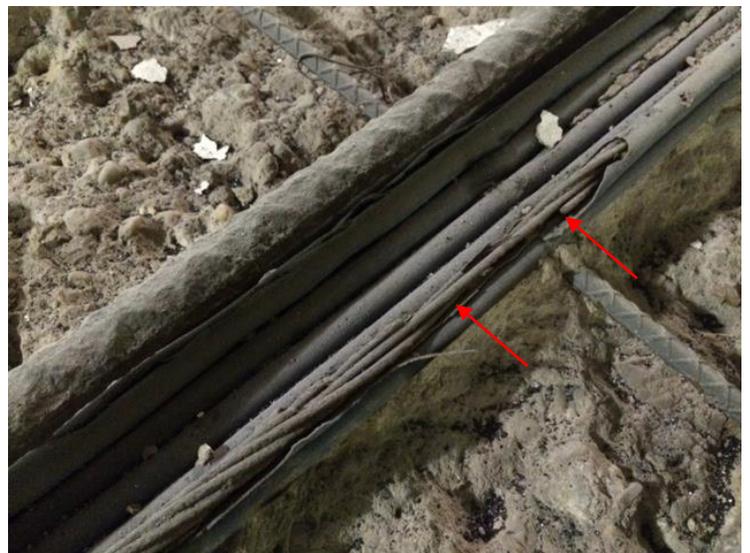
Photo 8 – Damaged sheathing around a PT tendon on a garage slab. Most of the individual strands from this 7-wire stand have corroded and severed.
