INTRODUCTION TO STUCCO FACADE

TCE & Associates

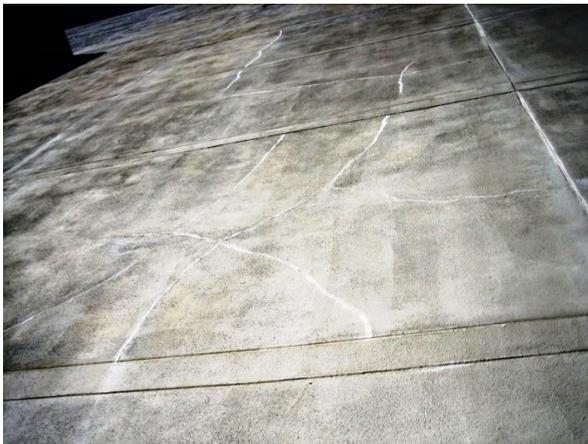
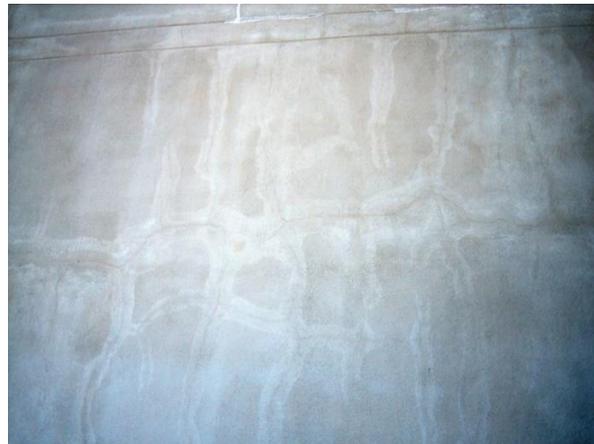
Typical map cracking due to excessive drying shrinkage

Cracking is a typical problem of stucco facades due to the brittle nature of stucco. Cracking can be caused by:

- Improper and varying thicknesses being used (often due to improperly installed substrate in direct applied stucco)
- Improper mixing of materials at time of placement
- Excessive drying shrinkage due to stucco not being properly moisture cured
- Lack or improper spacing of control joints

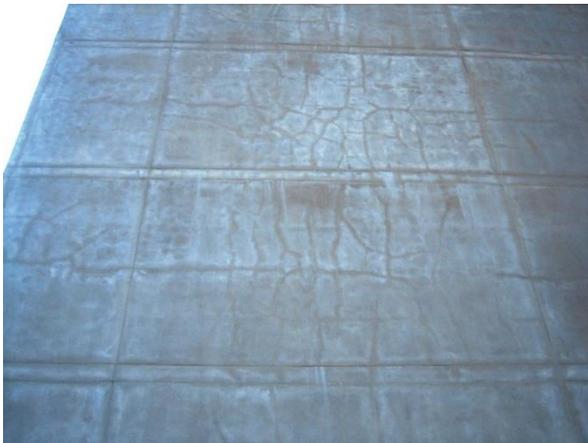
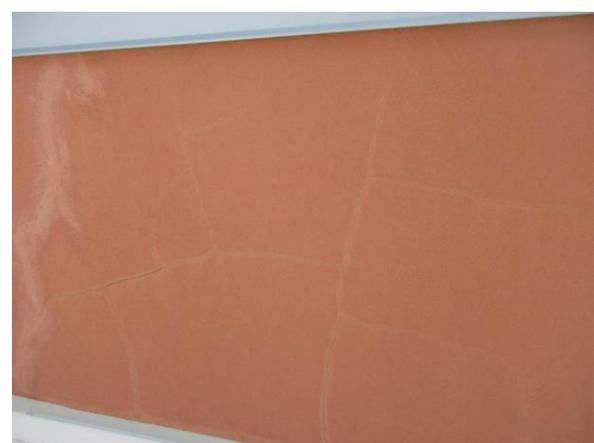
Typical map cracking due to excessive drying shrinkage

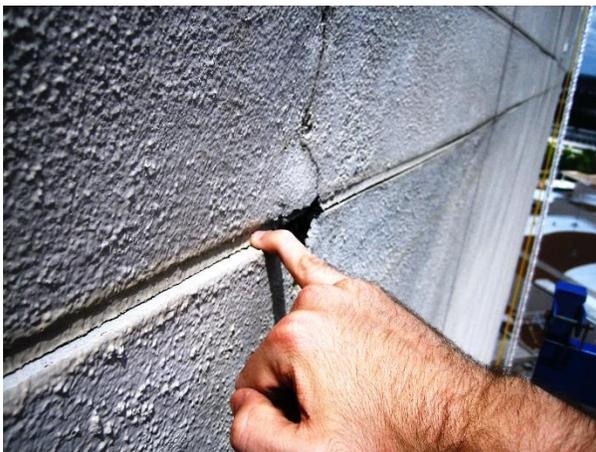
Stucco displaced due to failed lath fasteners

Corrosion and failure of lath fasteners is another common problem of stucco facades. The failure of lath fasteners can lead to large areas of stucco falling from buildings. Corrosion and failure of lath fasteners can occur due to:

- Lack of maintenance. Leaving stucco cracks unsealed
- Wrong type of fasteners being used
- Fasteners improperly installed (lack of embedment depth, spacing too far apart)
- Lack of drainage provided behind stucco

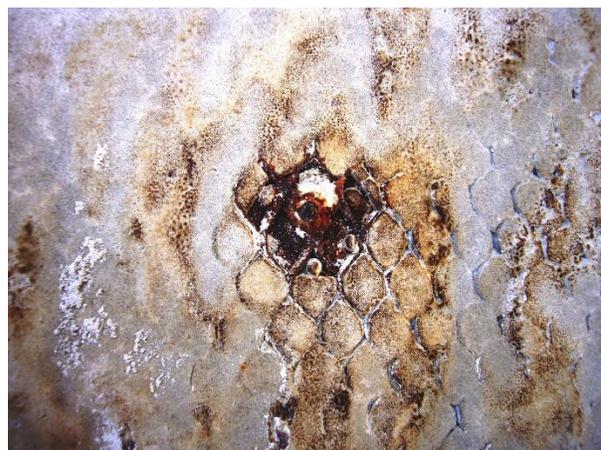
Corroded and failed lath fastener

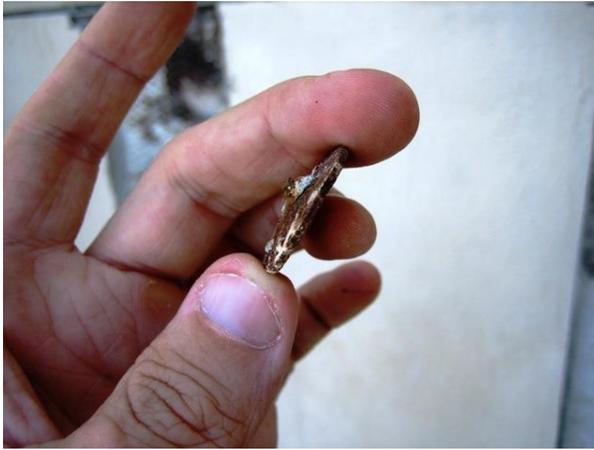
Failed lath fastener

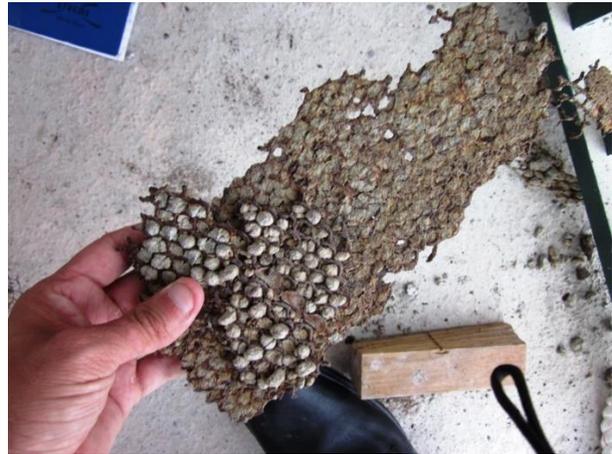
Severe corrosion of lath found at large unsealed crack in stucco
