PRECAST PARKING GARAGES

MAINTENANCE & REPAIR: PART 1

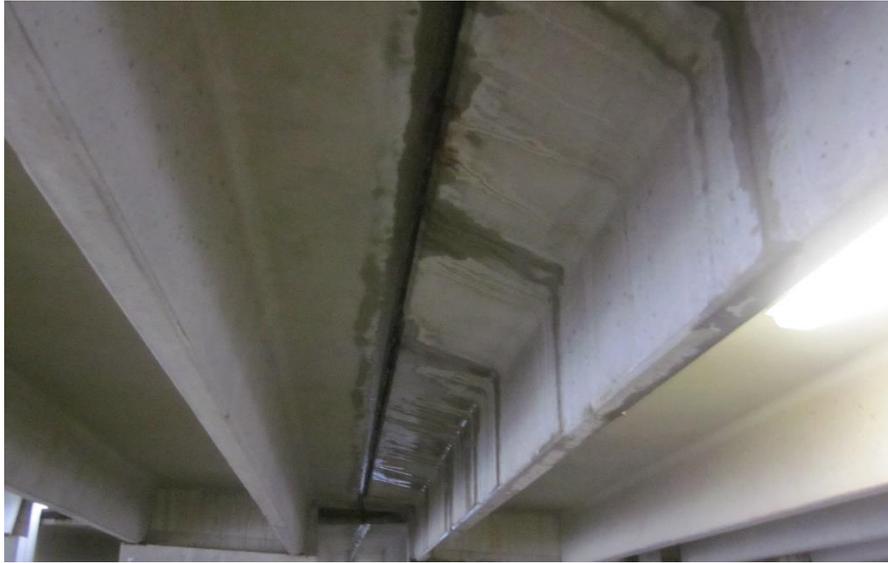
WATER LEAKAGE THROUGH FAILED SEALANT JOINT

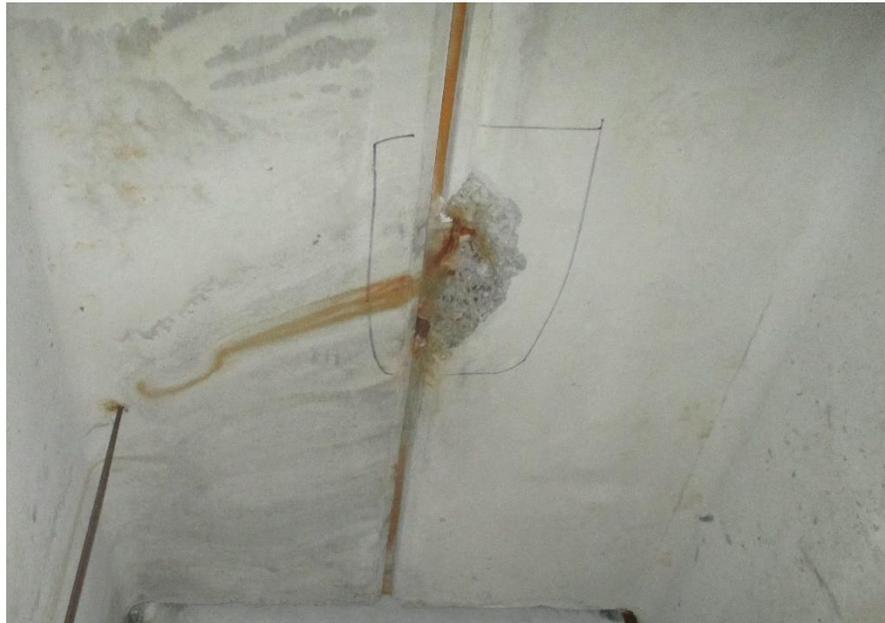
CORROSION RELATED SPALL AT SHEAR CONNECTION

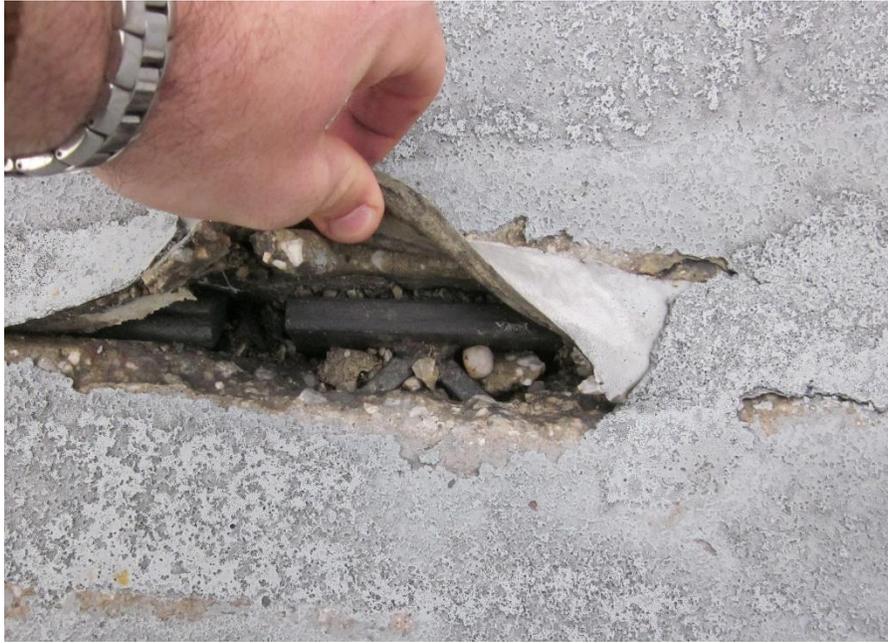
FAILED SEALANT JOINT EXPOSING A SHEAR CONNECTION

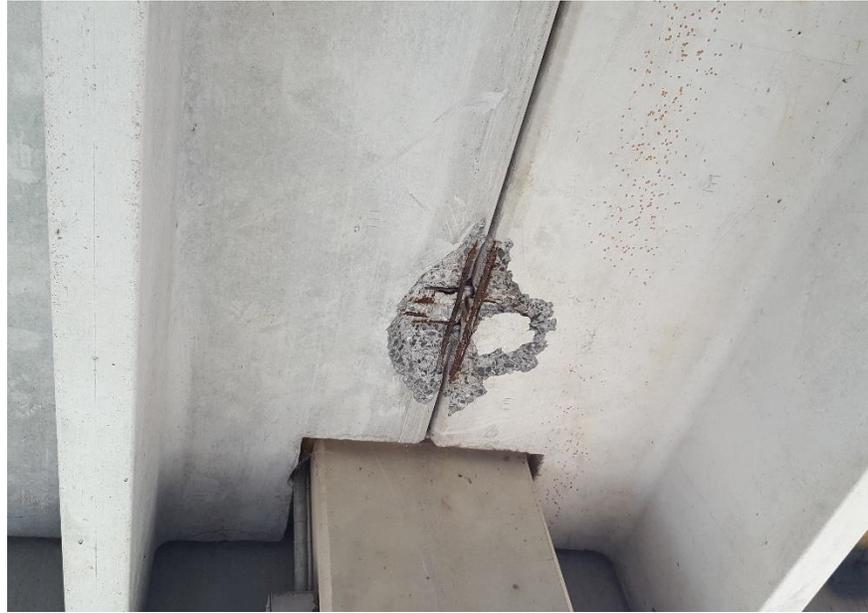
CORROSION RELATED SPALL AT A SHEAR CONNECTION

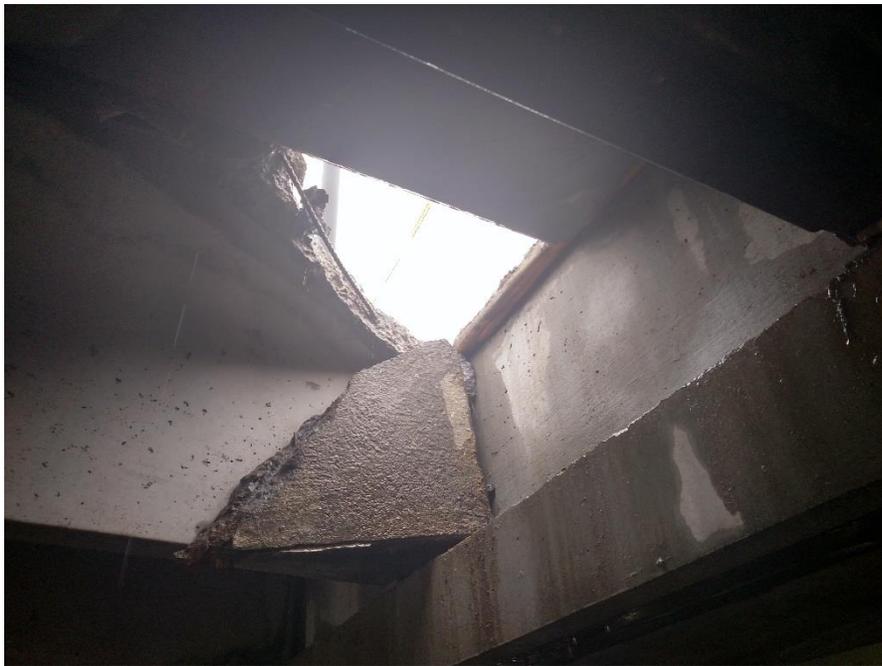
FAILED CONCRETE AT A DOUBLE-TEE FLANGE CORNER

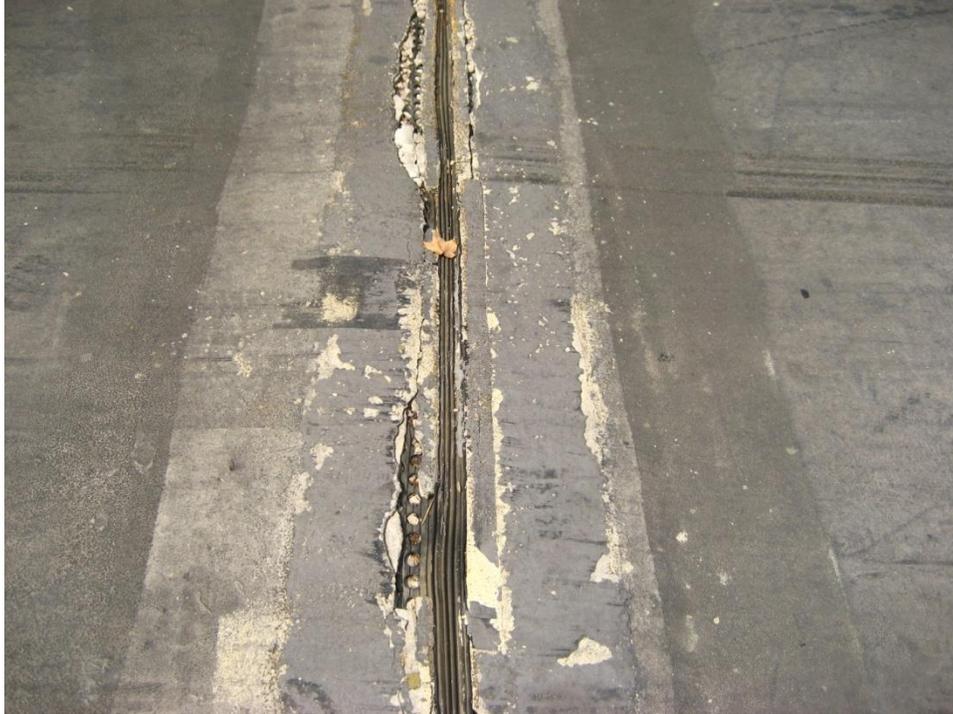
FAILED HEADER MATERIAL AND COATING AT AN EXPANSION JOINT

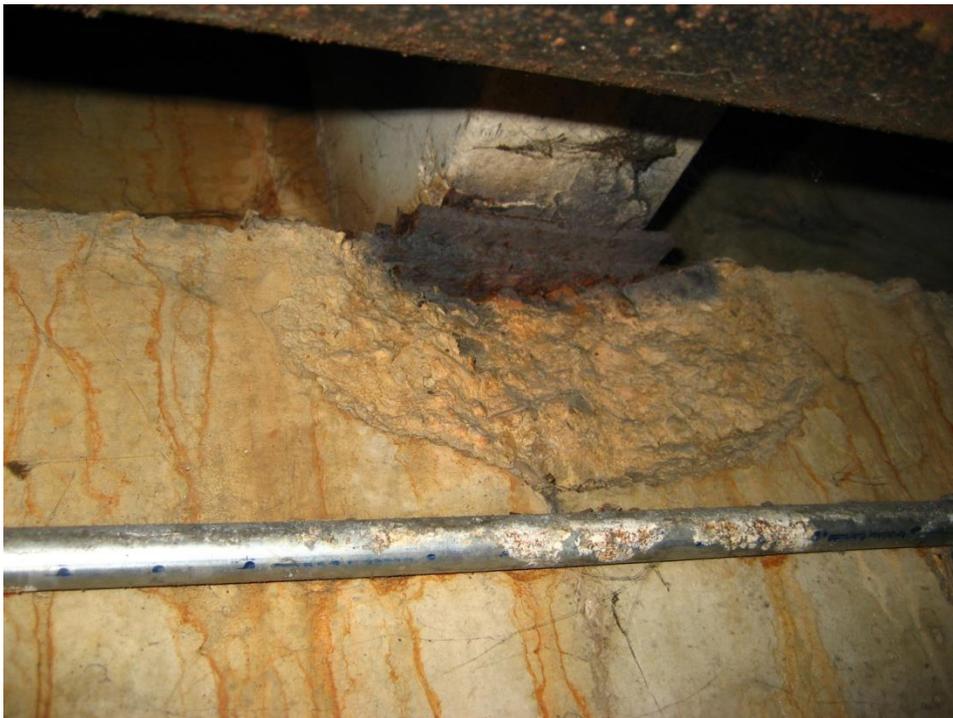
SPALLED CONCRETE AT A DOUBLE-TEE BEAM BEARING LOCATION
