### Parking Garage Deicing

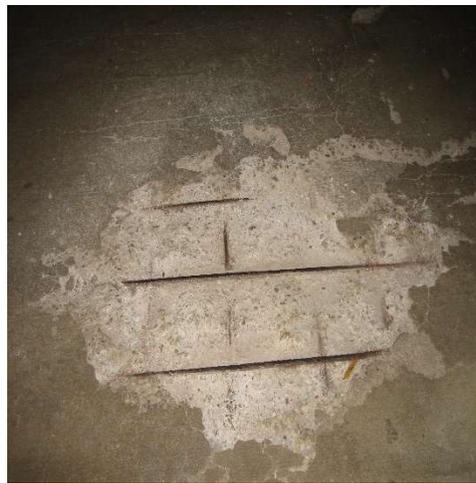
*Photo 1. Typical corrosion induced spall at a reinforced concrete slab due to chloride infiltration.*

When steel corrodes, the resulting rust occupies a greater volume than the original steel. The steel expansion creates tensile stresses in the concrete, which can cause cracking, delamination, and spalling. Unprotected concrete surfaces are porous and cracks create an easy path for water and chloride infiltration which speeds up the corrosion process.

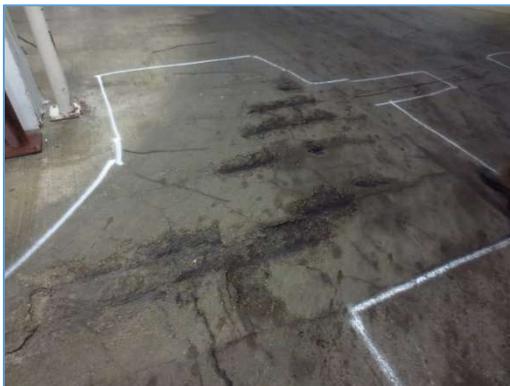
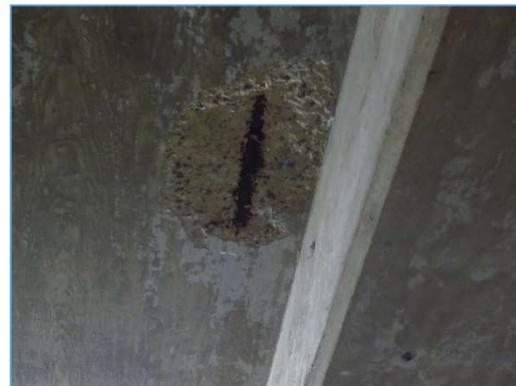
*Photo 2 and 3. Example of Delamination of Concrete Surface and Soffit of Structural Slab Due to Chloride Contamination*

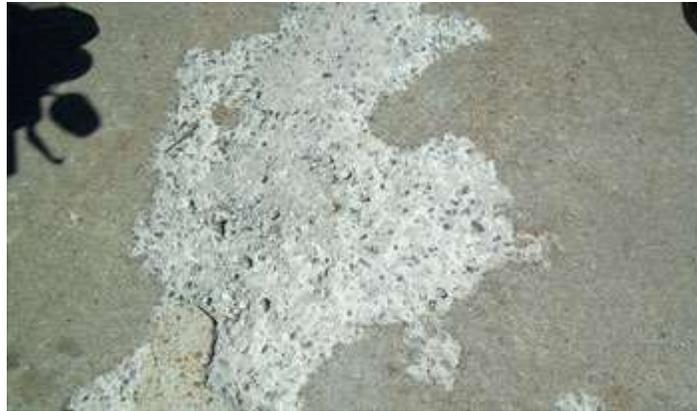
*Photo 4. Example of Concrete Surface Scaling*

Per the Precast/Prestressed Concrete Institute Maintenance Manual, deicing chemicals are recommended to not be used until the parking structure is at least one year old. The use of deicers on newly poured concrete including unprotected repair areas would have the same exposure. The manual also recommends that calcium chloride (rock salt) deicers not be used, in general. The rock salt, which is typically used, is relatively inexpensive, but is much more harmful to the structure than other deicers, such as Ureas or Calcium Magnesium Acetate. Ice melt products, especially rock salt, are also harmful to masonry and concrete pavers if used excessively or over long periods of time as deicer salts can contribute to surface scaling. Concrete surfaces exposed to freezing and thawing in the presence of moisture and deicing salts are more susceptible to scaling.
